Traffic Congestion at Road Intersection due to Absence of Efficient Traffic Management and Planning: A Case Study on Fulbarigate, Khulna

Keywords: Road intersection, traffic congestion, inefficient traffic management, on street parking, unplanned activities

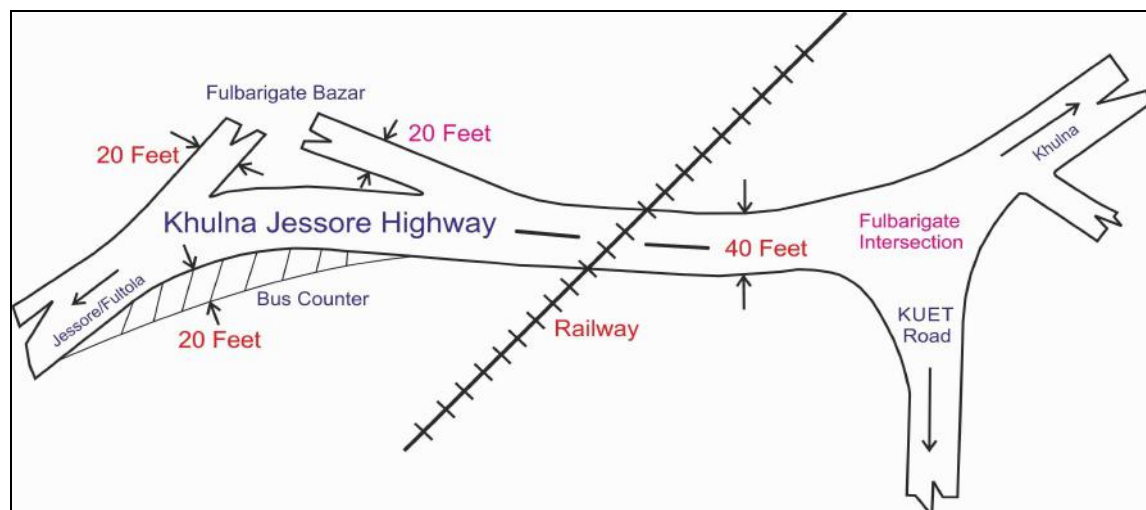
Median is dedicated to separate the vehicular flow moving in opposite direction to each other. It is also used to direct the traffic flow at a particular space. The existing median is in very poor condition and it is about one feet in width.

The surface of the pavement is very rough which creates greater frictional resistance between the tyre and road surface. The road surface is not smooth and damaged in various points which is very dangerous for a road intersection. Water logging is seen during rainy season and due to roughness of the surface water cannot pass over the road surface.

Figure 2: Layout plan of the study area

Camber was provided during the reconstruction of this road few years ago. But due to excess vehicular flow and heavy moving vehicle the crown is damaged at the midpoint of the road surface. Camber is provided for surface runoff. Due to absence of sloping surface runoff is interrupted and there are no proper drainage facility on both sides of the carriage way.

Sidewalks provided for this road is insufficient which cannot supply the demand requirement due to heavy pedestrian flow at this road intersection. The sidewalks are informal and are about two feet of width. Most of them are abused by the on street parking and on street shops as a result people tend to walk over the carriage way which is very risky.

Improvement of road condition is a must for this road intersection. Absence of a specific footpath results in street business at both side of the road and this causes congestion to pedestrian movement. Providing separated footpath, kerb to separate footpath from carriage way, a median to separate two lanes, improving road surface, providing an efficient speed breaker to control the vehicular speed at the point of crossing will improve the overall condition.

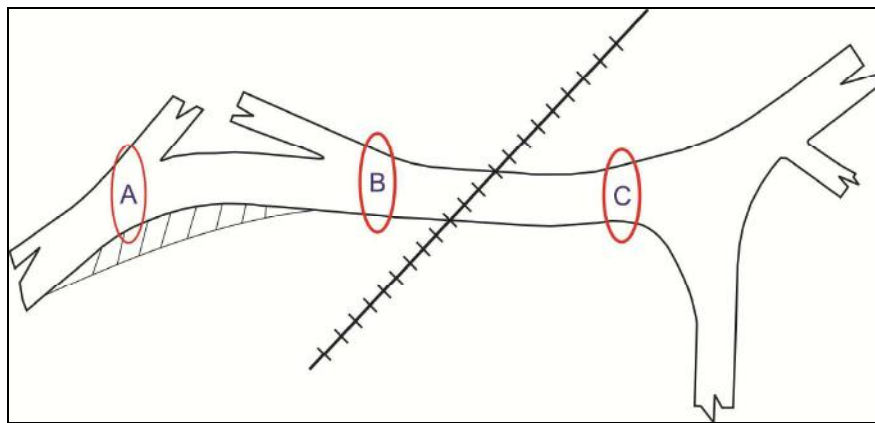
In this road intersection there is no specific space for the pedestrian to cross the road or any existing zebra crossing. A huge no. of pedestrian cross this highway which is too risky and often slows down the regular vehicular speed. From the field survey we see that point C is the most used crossing point and it is a must to

provide a zebra crossing in there. We can also see that during the evening hour the pedestrian movement is very high comparing to the other time of the day. The major crossing point A, B & C are shown below in figure 6:

Figure 7: Observation points of pedestrian crossing

From the figure above the important crossing areas were identified at A, B and C. These points need efficient safety measurement as user friendly crossing services. In this regard zebra crossing should be provided for safe crossing of the pedestrians. It should be noted that crossings should appropriately sited with respect to the road geometry, i.e. avoid bends, departure sides of crests. Motorist parking too close or on a pedestrian crossing should be prevented. It is beneficial to both the users and the installing authority because of relatively low cost installation and less delays to motorists than signalized crossings. The width of painted lines on zebra crossings range between 3 m and 6 m; MRWA standard is 3.7 m. For crossings without kerb protrusions, parking must be restricted for a minimum of 20 m on the approach and 10 m on the departure side of the crossing to achieve minimum sight distances. (*Planning and designing for pedestrians: guidelines*)

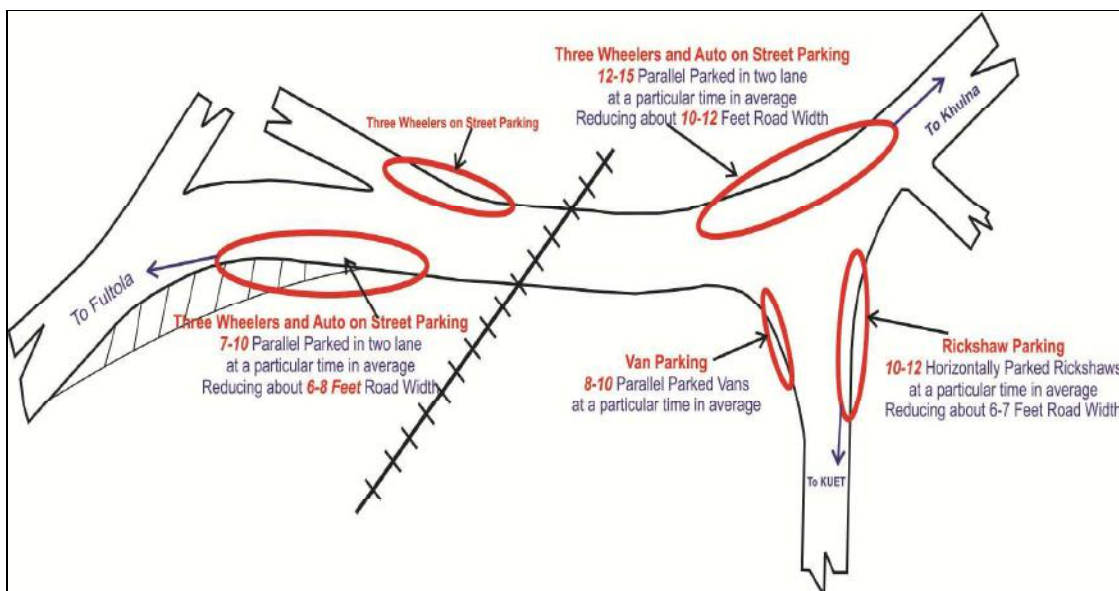
On street parking in this highway is a common phenomenon. But drivers follow no rules in maximum case. Parking at the points of road intersection, on street parking of vehicle in two bays, parking vehicle in a wrong manner is most common scenario. Parking volume in road intersection is given below in figure 7:

Figure 8: Onstreet parking locations with number of vehicles parked in average

To avoid collision at this point of intersection as well as to maintain regular traffic flow parking rules and monitoring should be imposed strictly. On street parking in several lines should be prohibited. Parking of three wheelers in the parking lot should be banned to ensure parking facility to buses. Parking lots for the vehicles should be specified. Horizontal parking of rickshaw and at the point of intersection which most common in this case study area should be banned and maintained strictly. On street business at the parking lot shown in the figure and the shoulders of the road should be strictly prohibited to ensure enough spaces for parking. Getting passengers on road and delaying for 5 to 10 minutes should also be prevented. A specific parking space should be provided for the three wheelers nearby. Parallel parking by rickshaws and vans should be followed. To reduce unnecessary parking tendency of drivers a small amount of money can be charged to park for per hour.

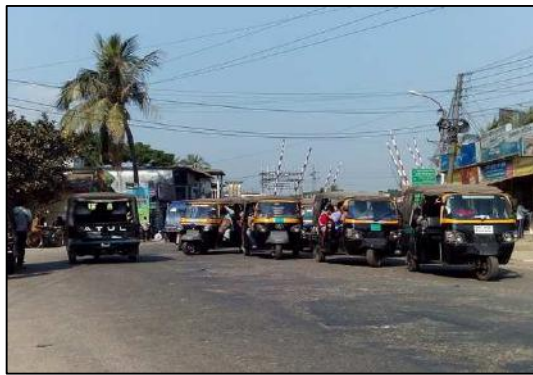
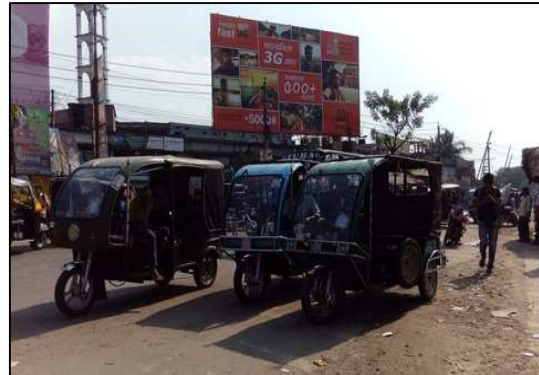
Figure 9: Unauthorized Parking causing reduction in road width (Source: Field survey-9/11/2015)

4.1.4 Reduction of Road Width Due to Unsystematic Parking

There are various public transport services such as ATUL, CNG and autos which travel to town. For passenger loading frequent on street parking is seen. There are no specific parking zone and parking regulation regarding the passenger vehicles as a result these vehicles stops on the streets without any concern. This may be dangerous

in terms of vehicles moving just behind the stopping passenger vehicle often cause accidents at this point. Two occurrences has been observed in recent times regarding this fact (Field Survey). In this study four problematic areas were selected which reduces roadway width by on street parking. The total roadway width is 40 feet but due to unsystematic on street parking this becomes 25 to 30 feet at the road intersection which creates problems for heavy vehicles like buses and trucks to pass between them. In addition, parking of slow moving vehicles like rickshaw and vans on the curves of merge and diverge act as an obstacle to the merging and diverging vehicles. There are about ten to twelve rickshaws and eight to ten vans parked on average in the major intersection leading to Jassore bypass road reducing roadway width about five to seven feet. Due to lack of insufficient space for parking this causes congestion in this intersection.
