# Building Setback Scenario in Different Sized Plots of Planned Residential Area: A Case Study on Nirala Residential Area of Khulna City, Bangladesh

Roy, T. K.<sup>1</sup>, Ferdous, A.<sup>2</sup> and Huq, S.<sup>3</sup>

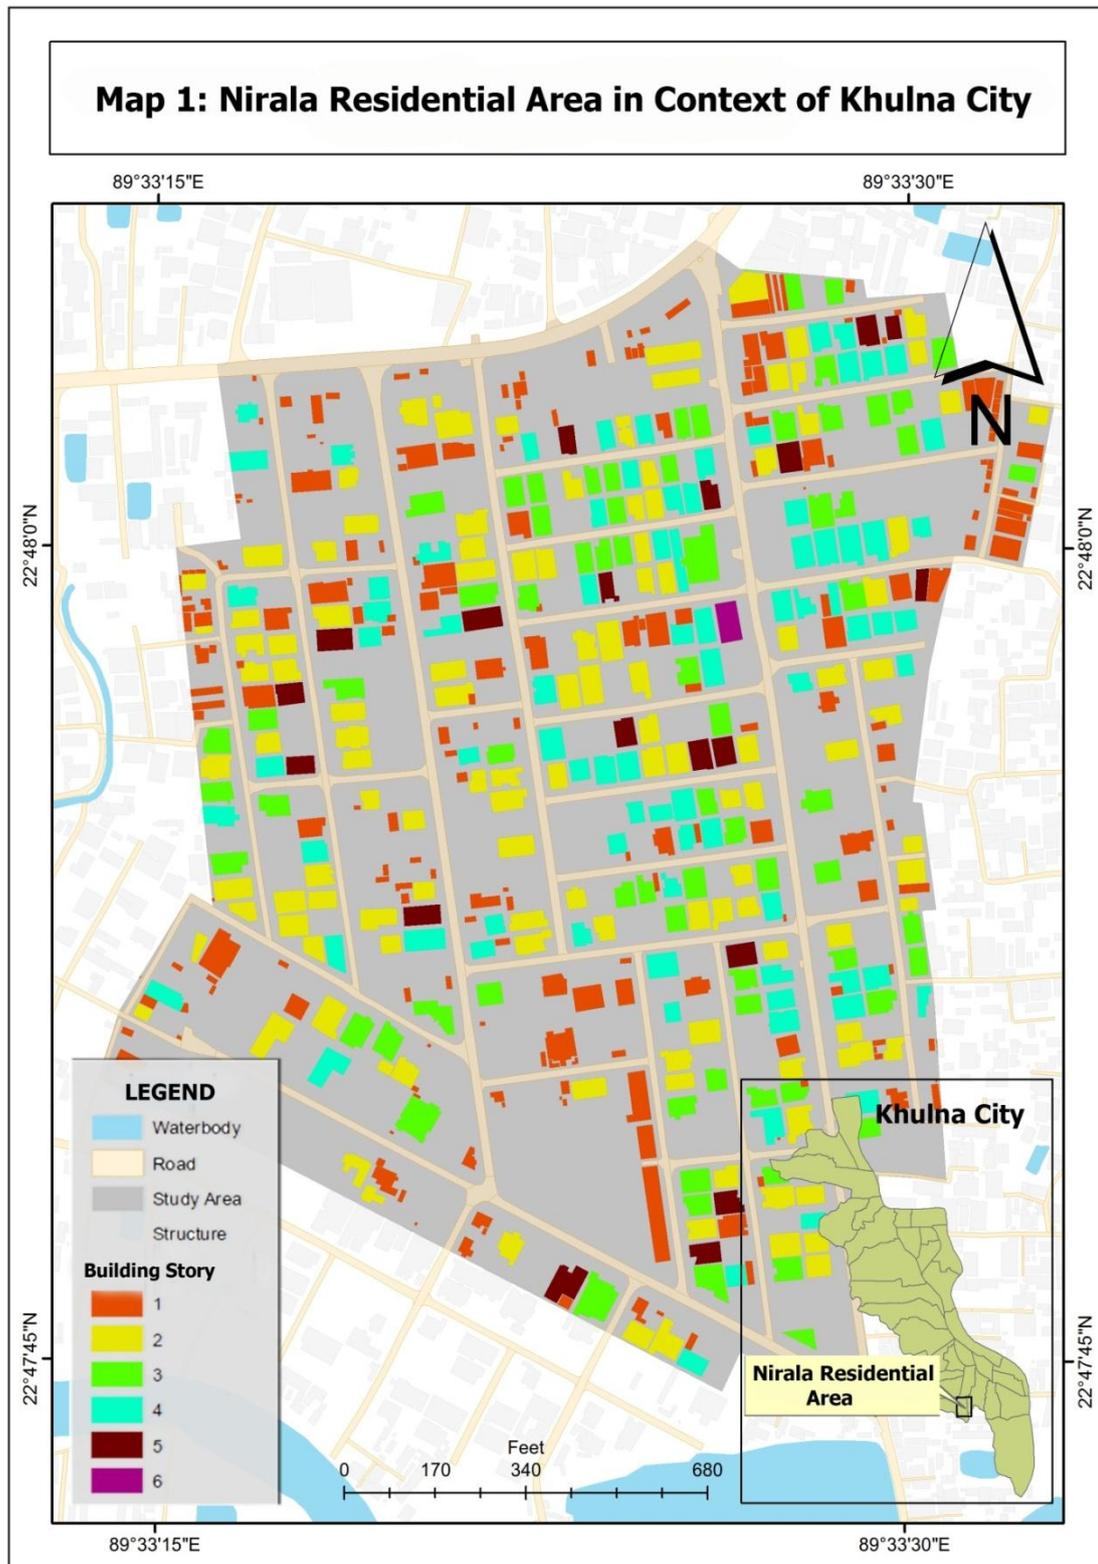
Nirala Residential Area is an old planned residential area of Khulna. It is located at the southern side of Sher-E-Bangla main road in Ward No. 24 of Khulna City Corporation. The residential area has about 3,000 population (Ray, 2012). Among the 595 plots, 300 plots have residential buildings (mostly having 3 to 5 stories), 25 plots have commercial buildings and the rest of the plots are vacant. Various types of community facilities that are generally found in a planned residential area are available in the area. The facilities include health, clinic, market, mosque, bazar, park, community centre etc. (Ray, 2012). There are 22 access roads linked with all the plots. The roads are finally connected to the Sher -E-Bangla road. Map 1 shows Nirala Residential Area where different colour of blocks represents different

building story. As example, green colour represents 3 story buildings. There are 46 one story buildings,133 two story buildings, 63 three story buildings,18 five story buildings, 5 six story buildings, 2 eight story buildings and 1 nine story building in Nirala Residential Area.

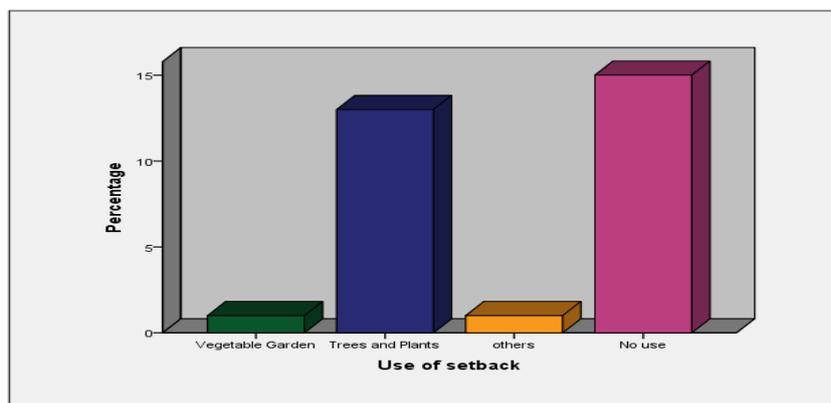
Figure 1: Different uses of building setback area in Nirala Residential Area  
Source: Field Survey, 2015.

Proper setback provides open space for landscaping and recreational use within the property boundary. If the rules and regulations are maintained properly that are related to the building setback then more open spaces can be found for various activities. In the Nirala Residential Area the amount of unused setback area of buildings is found 50% (Figure 1). Only 43% setback area is used for plantation that includes different types of trees.

In Figure 1 orange colour indicates other uses of setback. Other uses include drains, waste dumping place, small passage etc. No use means setback is totally covered with concrete pavement or hardscape area. Sometimes children use setback area as play lot for their recreation (Figure 2).

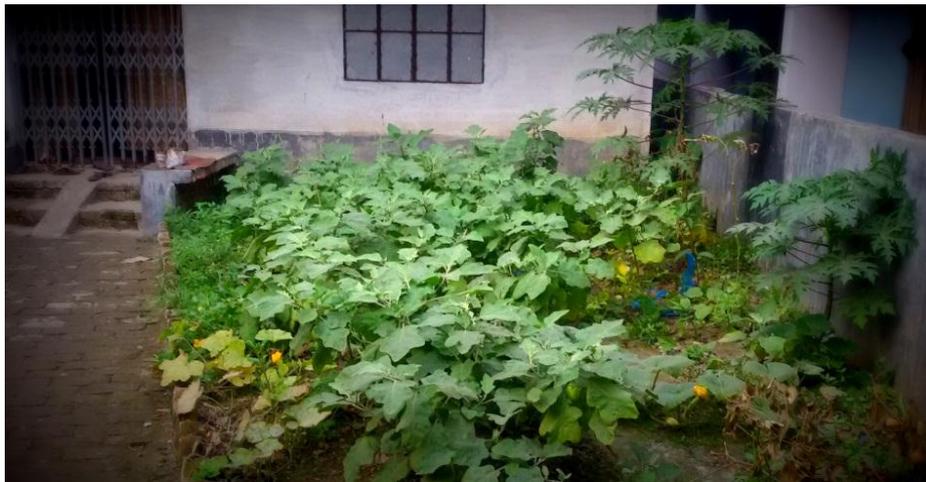
Figure 3: Use of setback for vegetables production  
Source: Field Survey, 2015.

About 2 percent of households have used the setback area for vegetables gardens (Figure 3). Different types of trees are planted in the setback area. Small flower gardens with recreational facilities can increase the aesthetic view of the buildings. This can create also healthy environment.

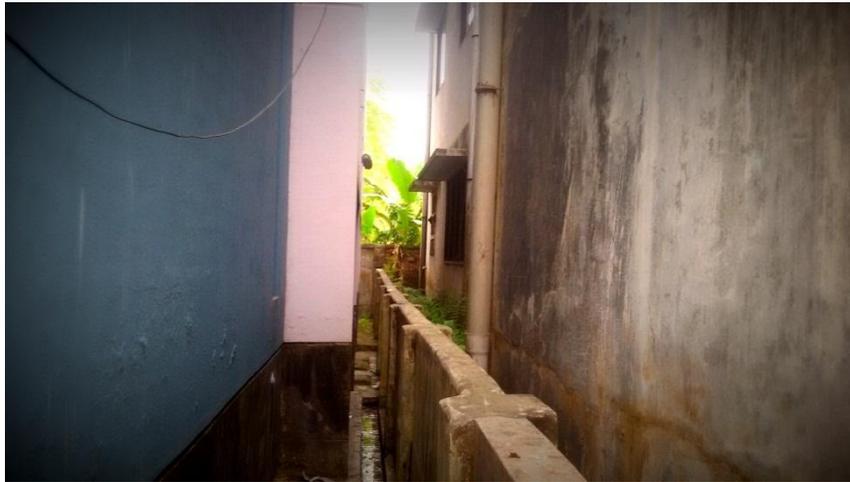
Figure 4: Buildings non-compliance of proper setback  
Source: Field Survey, 2015.

Residents of Nirala residential area are very vulnerable to these types of problems. The dwellers of such buildings are to suffer during load shedding at day times. Due to inadequate air and light people use more electricity that also increases electricity bill and family expenditure. Lack of natural ventilation system creates various health problems to the residents (Figure 4).

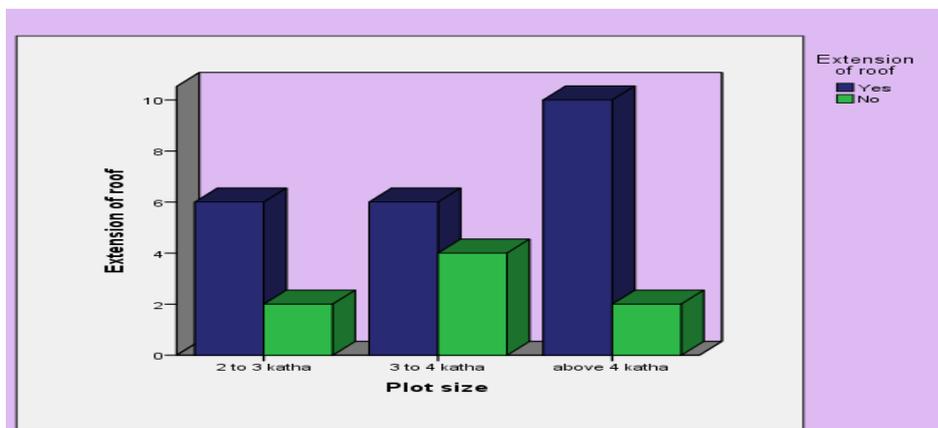
Figure 6: Extension of buildings at upper portion in different sized plots  
Source: Field Survey, 2015.

Extension of buildings from the second or third floor is a common scenario in Nirala Residential Area. It is almost seen to all the three categories of plot. People usually keep 3 to 6 feet open in the ground floor mainly for passage and then extend the buildings from upper floors violating setback rules. Such types of activities distort the normal design of buildings and reduce the space between two consecutive buildings. As a result privacy between the consecutive buildings is hampered. It creates safety and security problems to the buildings. Such situation creates enormous problems at the time of building repair, reconstruction and maintenance.

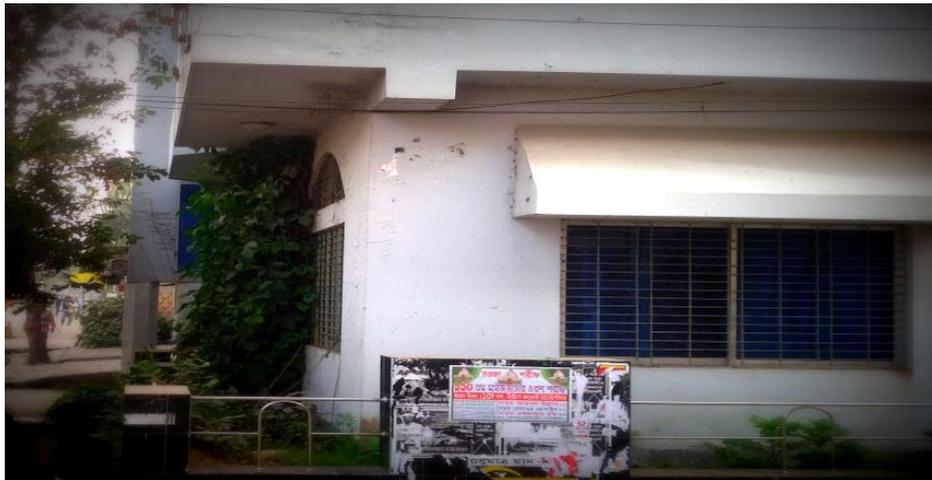
Figure 7: Extension of building at the upper floors  
Source: Field Survey, 2015.

Existing side setback scenario is presented in Table 2. Most of the houses in Nirala Residential Area did not follow minimum standards side setback. Sometimes, the owners use side setback as their entry to houses and extend the building from the second or third floor (Figure 7). It is found from the Table 2 that 25% buildings on 3 *Katha* land did not have any side setback within their building premises.

Figure 7 shows that more extension at the upper portion is seen to the buildings on 5 *Katha* land i.e. bigger sized plots. Smaller sized plots i.e. 3 *Katha* plots also influence the owners of the buildings in violating setback from upper floors as the land price is increasing day by day.

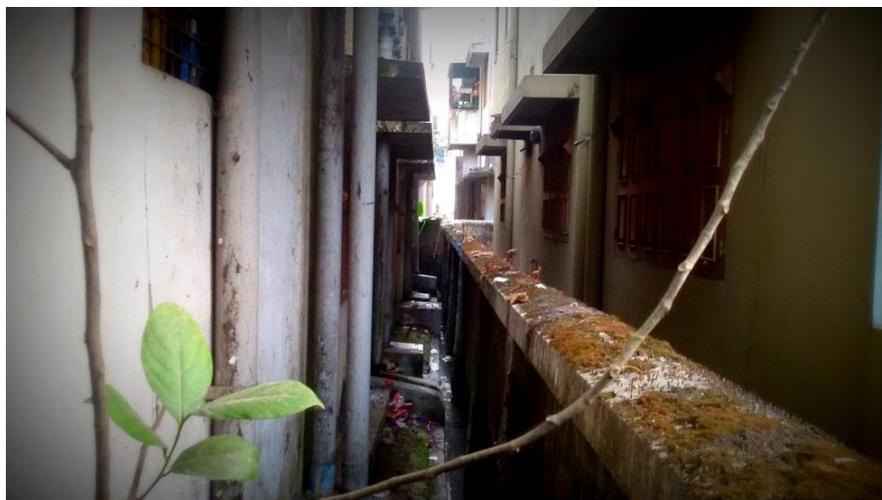
Figure 8: Solid wastes disposed in narrow setback space between two consecutive buildings  
Source: Field Survey, 2015.

The space between two consecutive buildings is so small that wastes disposed of there can hardly be cleaned properly (Figure 8). As a consequence, damp, unhealthy and uncomfortable living environment prevails that creates health problems to the dwellers (Kakon, 2012). Moreover, such problem also causes breeding of mosquitoes and the residents often suffer from Malaria. Bad smell spreads into the houses and people cannot escape after closing the door and windows. Children and older people suffer most.

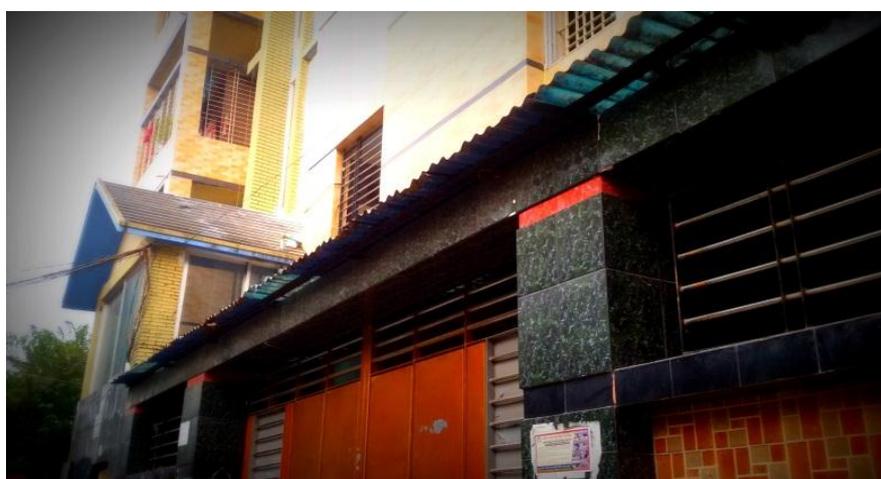
Figure 9: Building without setback and softscape

But it is not enough for a better an environment buildings. Presence of Softscape area covering grass and vegetation serves as infiltration area for storm water runoff. Figure 9 shows a building of Nirala Residential Area that has completely violated the setback rules. It did not sacrifice any space for setback. Total entire land area covered by the building and the boundaries are almost with road. There is no space for tree plantation or gardening.
