Pedestrian Facilities at Khulna CBD

Abstract

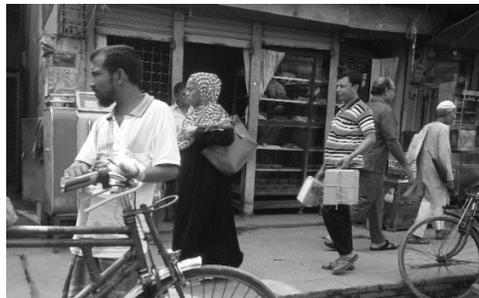
Figure 5: People walking in both directions in a single footpath

Footpath, as is the major element of pedestrian facilities which should be at least 3.50 to 4.50 meter in width, is although available along with most of the vehicular roads but lacks proper width and management. In the study area, the highest width of the footpath is 1.8 meter, which is too poor to accommodate proper pedestrian facilities in areas like CBD. In the most situation, the insufficient footpath width fails to support the excessive pedestrian flow, while some footpath is only available on one side of the vehicular roads (Table 2). Therefore, to fulfil the pedestrian demand of the other side of the road, pedestrian have no other ways than to walk in the middle of the vehicular roads, which led to traffic congestion and inconvenience of walking. Due to the poor management and regulation, people often choose to walk in both directions of a single footpath (Figure 5), which creates pedestrain collisions.

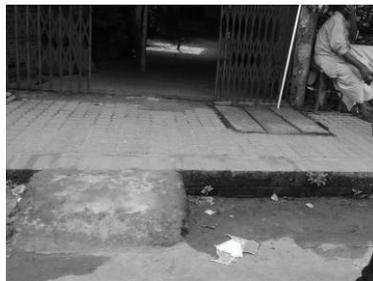
Figure 7: Improper kerb alongside the footpath.

Kerb being another indispensable pedestrian facility, should be available in connection of crossing, which is absent with the absence of footpath. However, in adjacent of some footpath regarding connection with the vehicular road, there is some kerb ramp present. Whether some of these kerb ramp facilitates walking of the aged people because of easy access from vehicular road to footpath, some other create hurdles because of it's inappropriate height (Figure 7). In most of the scenario, these kerb ramps are developed without any proper consideration, which is apparently indicated by the differences between various heightened kerb ramp along with their availability and absence with different footpaths (Table 3). For example, the lowest height of kerb ramp is 4 inch along with some footpath throughout Clay Road, whereas the highest elevation of the kerb ramp is 6.5 inch in Upper Jessore Road. Moreover, in the Railway Hospital Road and in a major portion of cemetery road kerb is absent along with footpath. However, neither of these kerb are continuous, nor are properly maintained. Because of improper management, these kerb are often used as the extended stair of the shop frontages, which instead of providing easy access to footpath, create difficulties as these shop frontages reduce access to the footpath.

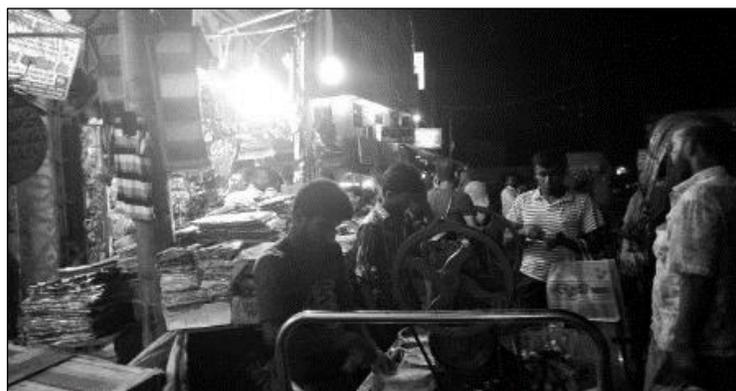
Figure 8: People walking in the light of street shops.

Although street light is available along most of the roads throughout the area, there are problems with the installment locations of the street lights, maintenance and the distance between the lights are not uniform. Moreover, due to the poor maintenance, some of these lights are out of order. The electric poles of these street lights are installed in a way that hinders pedestrian vision. Moreover, although there is street light pole available throughout the Upper Jessore Road, there is hardly any light with this pole which reflects the poor maintenance. Most of these lights are mounted facing the carriageway, that is why instead of supporting the pedestrian movement they are failing to provide a safe environment for the pedestrians. However, to meet the need, some people have to walk, who mainly walk through in the light of street shops (Figure 8), which reflects the improper distribution of street lighting.

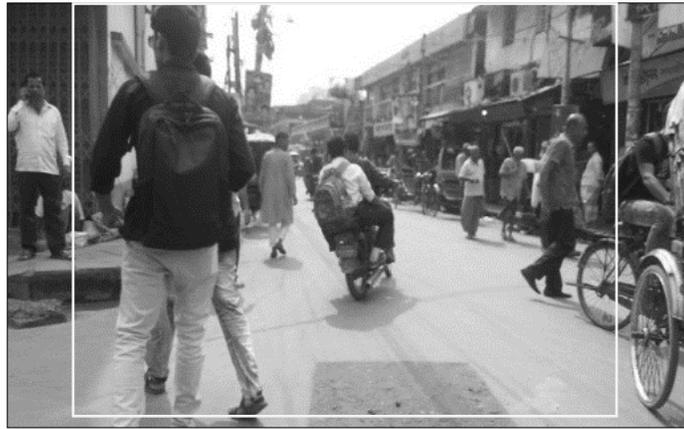
Figure 9: People crossing the street haphazardly by risking their life.

Without proper crossing arrangement and zebra crossing the pedestrian facilities of the study area remains very poor. People have to cross road haphazardly in the middle of the vehicular street by compromising their safety issue (Figure 9), which further is responsible for traffic congestion, especially at the intersections.
