OBSERVATION ON RECENT OCCURRED CATASTROPHIC LANDSLIDE AT RANGAMATI TOWN, CHITTAGONG HILL TRACTS

M. Chakma¹, S. Chakma²

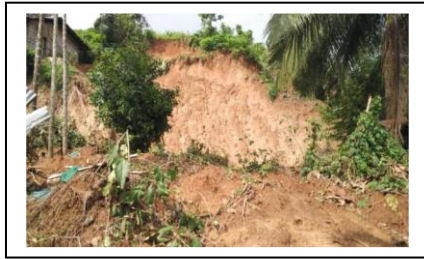
Figure 1(a)

2015). Disaster had a profound impact on people's emotional wellbeing affecting their feelings, thoughts, actions, and relationships. Figure 1 shows the devastation of landslides happen in Rangamati area on 13th June 2017. It is estimated the total damages property in Taka is about 2000 crore (Hasan, 2017).

In figure 1: (a) and (b) shows Land slide affected areas in Rangamati. Vegetation protects the top hill soil and makes hill slope stable, reduce of plantation in the hilly areas caused landslides in Rangamati on 13th June 2017 (Pertha, 2017a; Sultana, 2013). Furthermore, at recent periods hill cutting, illegal and unplanned development was occurring in the landslide affected area. Mayor, Rangamati municipality pointed out that in the landslide affected area 95% houses are illegally constructed and did not maintained any building codes (Channel24, 2017c). From field survey, it was clear that affected houses were built with tin, wood and cheap materials. Moreover, construction of these houses did not follow local indigenous techniques which naturally used in the same region. Houses were built by cutting the hill top by loosening top hill soil sometimes hills are cut down 90-degree angle. At present some hills are being cut down by land grabbers and this kinds of indiscriminate hill cutting are responsible for landslides in hilly areas (M. Rahman, 2010). Heavy rainfall triggers landslide worldwide. Soil compaction is loosed by heavy rainfall and increases weight of top soil of hill, on the other hand gravity pulls this heavy soil and causes landslides (Gunter et al., 2008; T. Rahman, 2012). Rangamati was receiving rainfall since "mora cyclone" which was occurred on 30th may 2017. After Mora there was regular raining in the Rangamati region. On 11,12 and 13th June 2017 Rangamati received 564mm rainy water during short time period which is the highest in its history and probably triggered landslides (Network, 2017; Weather office, 2017).
